Inspection Report Minerals Regulatory Program

Mine Name: Topaz Valley Limestone Operator Name: Rancho Equipment

Mine Status: regraded and seeded

Permit number: M023/022 Inspection Date: 09/29/2005 Time: 10:30-11:30AM

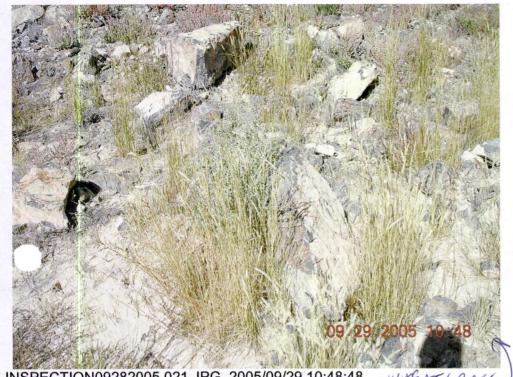
INSPECTION09282005 021.JPG 2005/09/29 10:48:48 WHEAT 6 RASS
